**Single-Family Home in Puerto Vallarta**  
Ojo de Agua, Puerto Vallarta, Jalisco  
House / Villa

**Sample Client**  
Buyer (Pre-Purchase)

**Carlos Méndez**  
InterNACHI Certified Member  
+52 322 145 9080  
hola@solterrainspecciones.mx

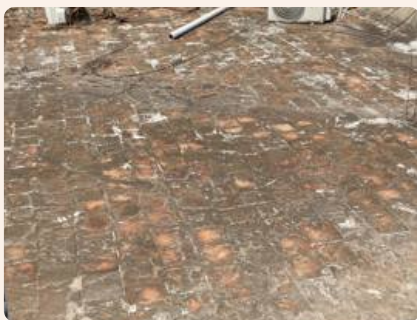
#### Waterproofing Membrane (Impermeabilizante)

MAJOR DEFECT

Entire roof needs to be sealed.

Needs to be sealed.

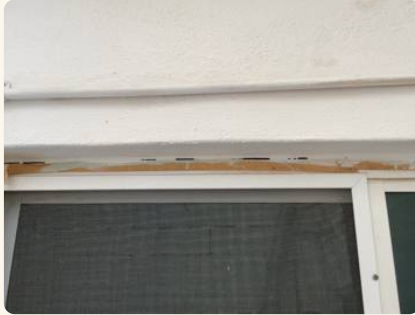
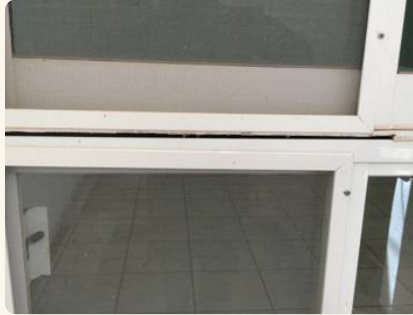
### Windows & Frames

Missing part of frame on back window.  
Caulking needs to be done on the other window in back.

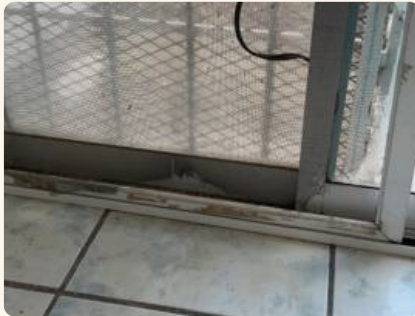
### Exterior Doors

Front sliding screens need to be repaired.

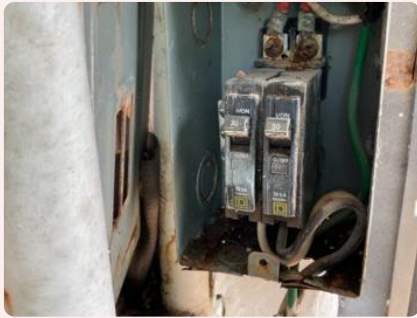
### Panel — General Condition

SAFETY HAZARD

Panel needs weatherproofing. There is a voltage drop at the screws due to rust.

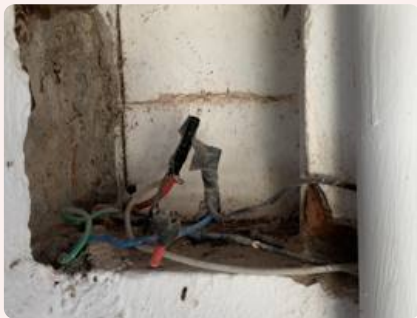
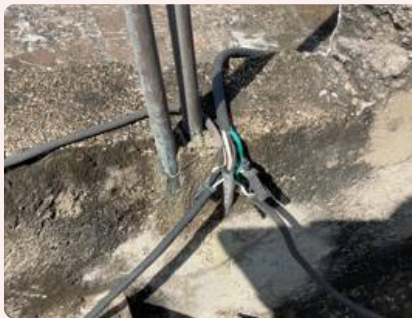
### Visible Wiring Condition

SAFETY HAZARD

Wires visible and electrical-taped in the open.

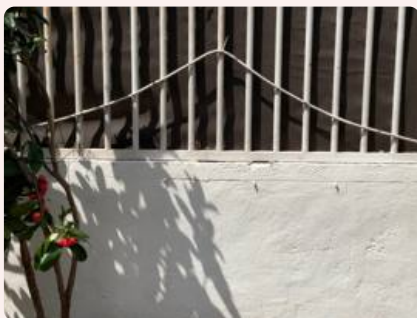
### Exterior Wiring & Conduit

SAFETY HAZARD

No conduit.

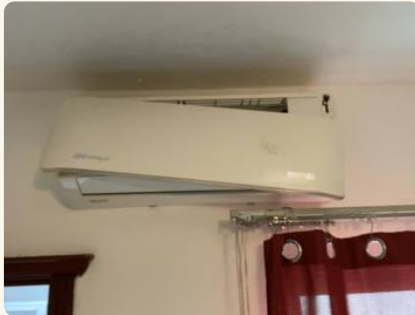
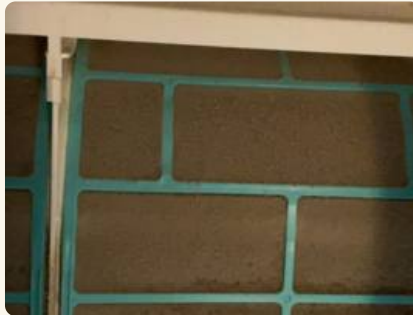
### Mini-Split — Filter Condition

Filters need to be cleaned.

Unit in master bedroom has a broken right-side hinge.

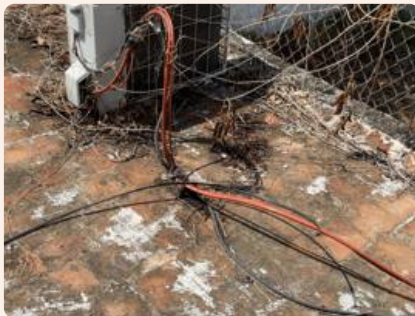
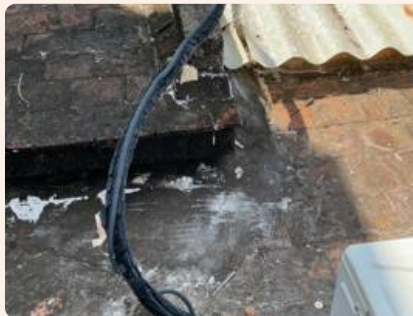
### Mini-Split — Refrigerant Lines & Insulation

MAJOR DEFECT

Insulation needed on 2 condenser units.

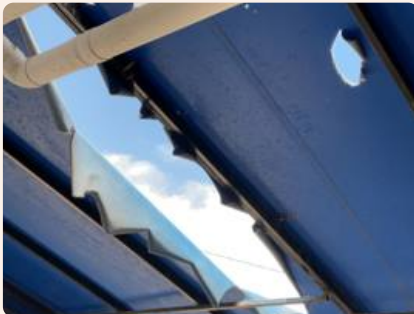
### Walls & Ceiling

MAJOR DEFECT

Hole in tarp material.

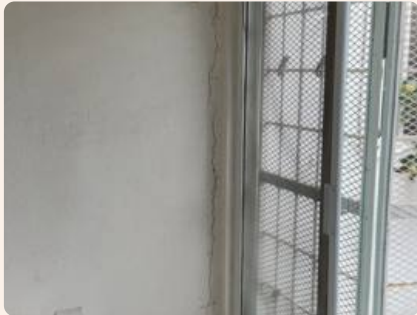
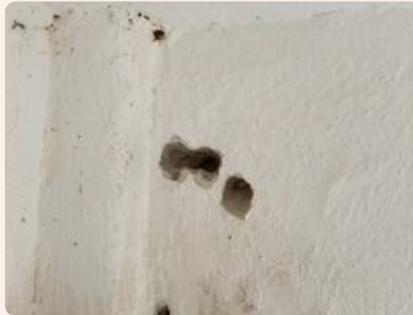
### Walls

MAJOR DEFECT

Floor-to-ceiling crack near the door at the front.  
Drilled holes above door.

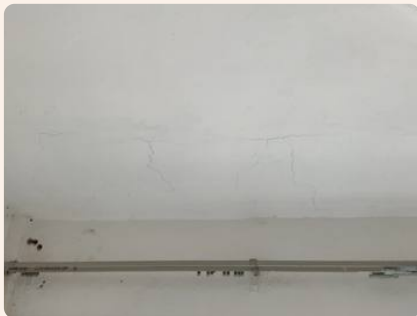
### Ceiling

MAJOR DEFECT

Crack along the front-door area — may just be the stucco.

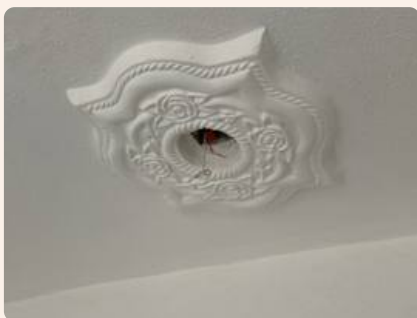
### Light Fixtures

MAJOR DEFECT

Secondary fixture missing.

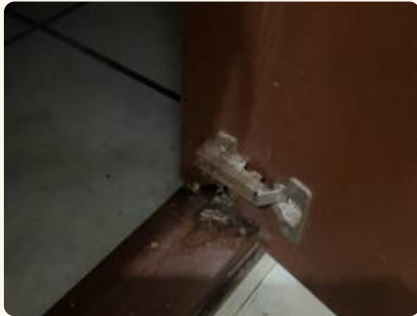
#### Cabinets

Cabinet doors above the counter on the left have loose hinges. Right door above the range rubs on the hood. Right door below the sink has water damage at the lower hinge.

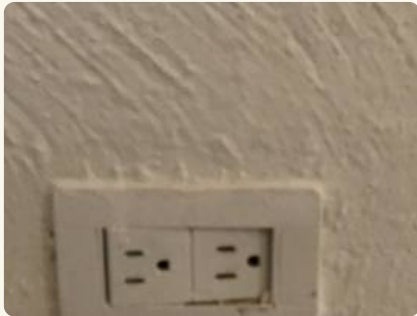
### Electrical Outlets

Left outlet on back wall is pushed in.

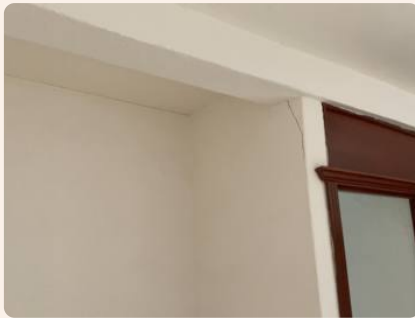
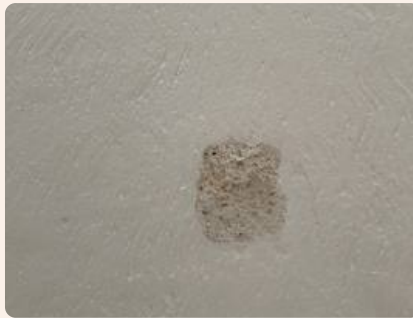
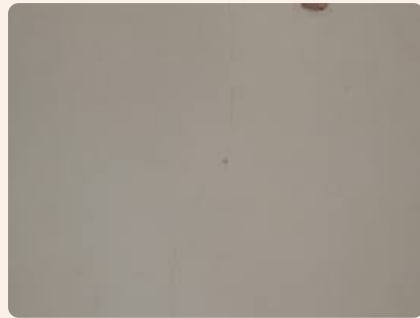
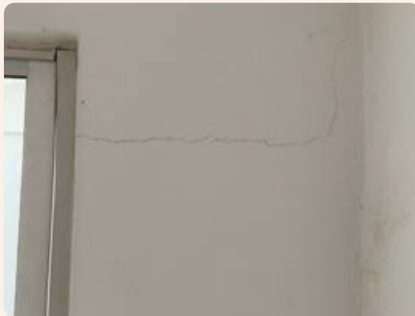
### Walls

MAJOR DEFECT

- Floor-to-ceiling crack on the wall opposite.
- Crack from the living room visible on the shared wall.
- Large hole in wall stuffed with an unknown object.
- Crack near window.
- Patched hole.

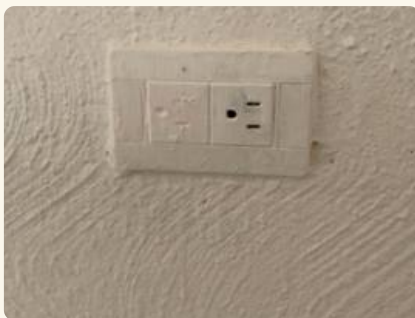
### Electrical Outlets

Outlets functional but painted over.
